5th QUARTERLY PROGRESS REPORT

PROTECO LANDFILL SUPERFUND SITE

Peñuelas, Puerto Rico

Report Date: July 15, 2022

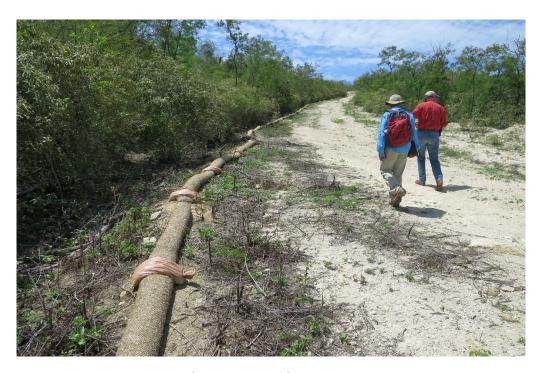
BMPs along access road to Waste Unit 14

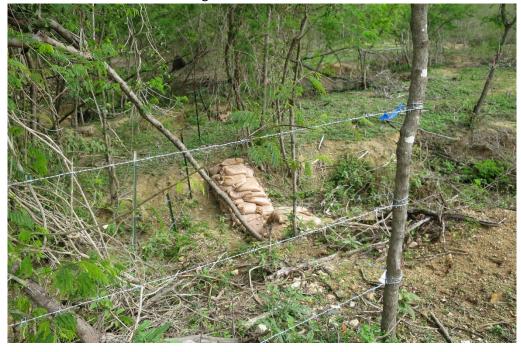
BMPs installed in storm drainage channel near west Site boundary

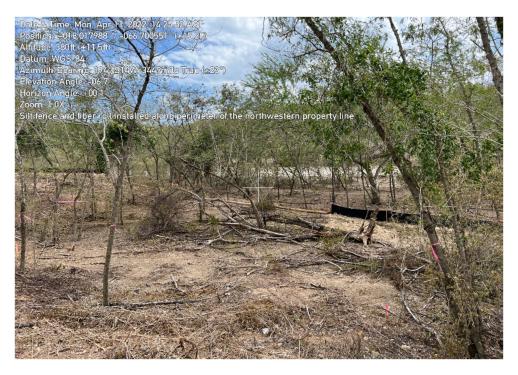
BMPs along northwestern Site boundary

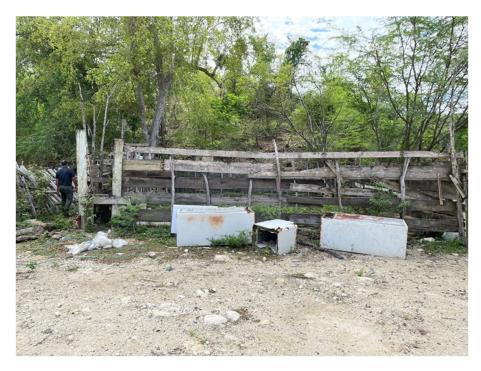
Livestock Pen and Abandoned Refrigerators Near West Gate

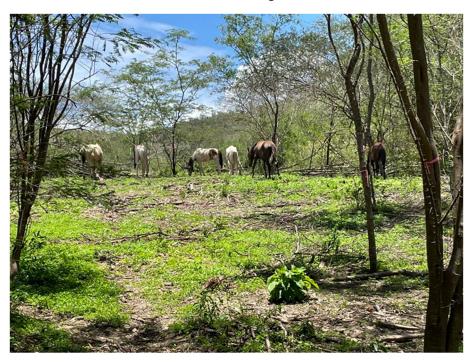
A Group of Six (6) Horses Near CAMU 9 and West Gate

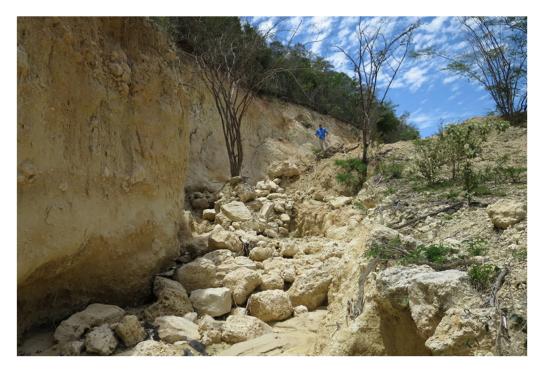
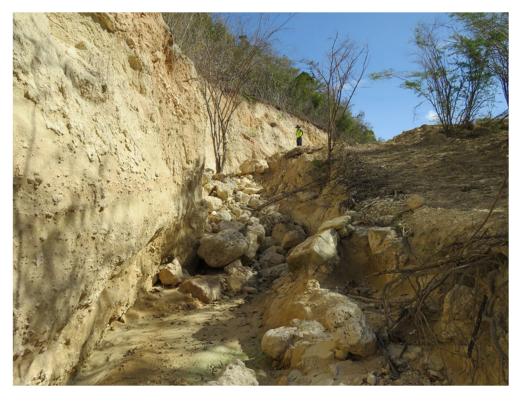
West Abutment Lower Sedimentation Pond Dam, May 3, 2022

West Abutment Lower Sedimentation Pond Dam, June 25, 2021

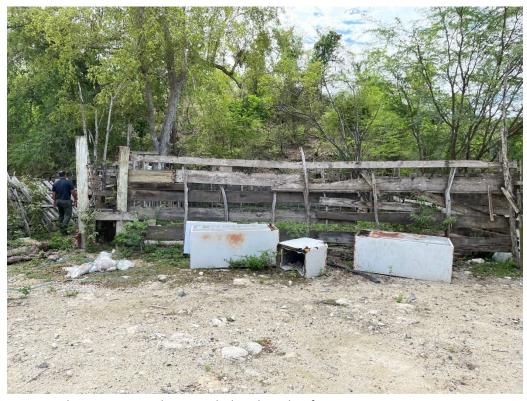
There were seven (7) horses present inside the Site fence near the west gate area. The horses were observed by the EPA representatives and the Group representatives. The horses remained in the general area of the animal pen and Corrective Action Management Unit (CAMU 9) during the SRV. The EPA representatives were shown the animal pen, loading chute and a barbed wire corral that are located near the west gate inside the Site. The EPA representatives were shown the abandoned refrigerators which the livestock owner uses to water his animals. Photos 1 through 4 show the livestock pen, abandoned refrigerators and horses in the west gate area.

Photo 1: Livestock Pen and Abandoned Refrigerators Near West Gate

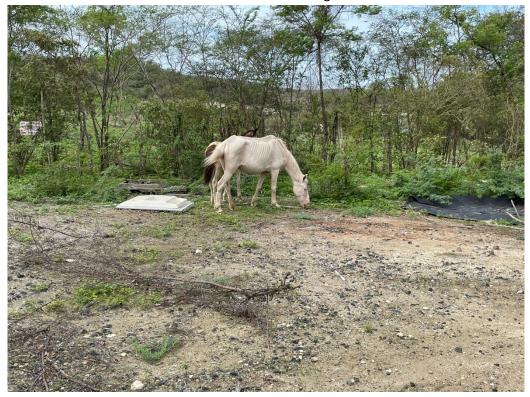
Photo 2: Horses and Debris Near Livestock Pen in West gate Area

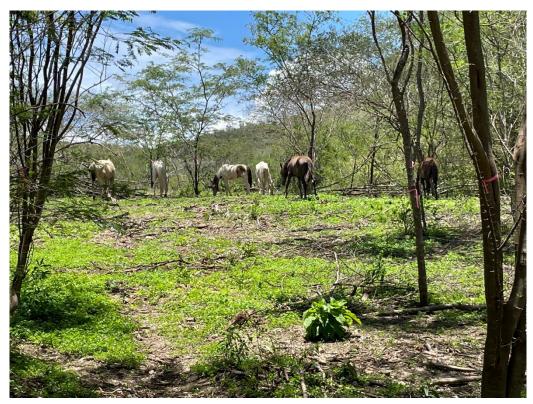
Photo 3: A Group of Six (6) Horses Near CAMU 9 and West Gate

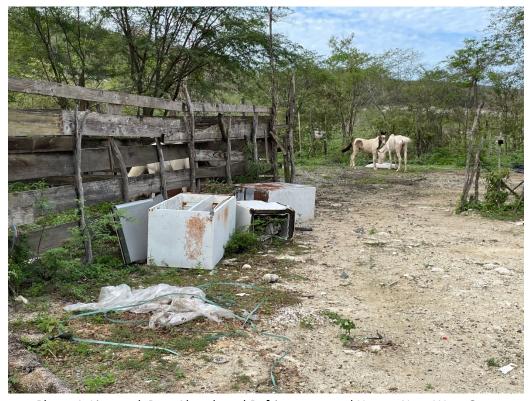
Photo 4: Livestock Pen, Abandoned Refrigerators and Horses Near West Gate

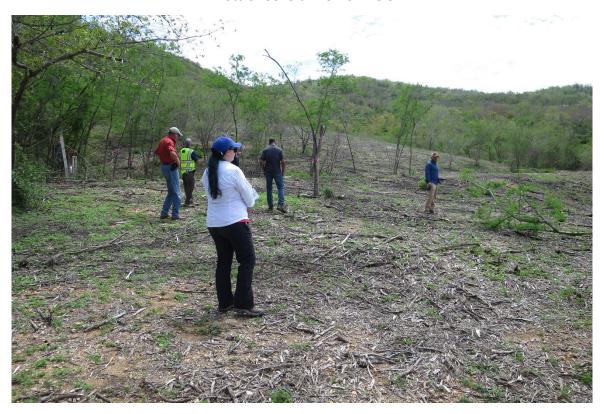
The group walked from WU 5 to WU 1. There is an old access gate present in the fence on the north side of WU 1. The broken strand of barbed wire observed by EPA on April 14, 2022, was adjacent to this gate. It would appear that this strand of wire was broken by a tree limb because the brush on the outside of the fence is too dense for the livestock to pass through to access it. The broken strand of wire will be repaired during a future Site inspection visit. Photo 6 shows a general view of WU 1.

Photo 6: General View of WU 1 (WU 2 and WU 3 in background)

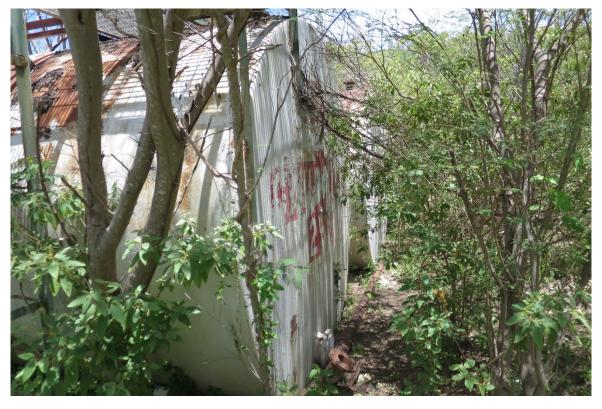
The group walked to the four (4) ASTs located across the access road from the southwest corner of WU 14 and to the east of the reported (Weston 2019) location for WU 8. The ASTs lie horizontally and have the approximate dimensions of 10-feet in diameter by 50-feet in length (estimated 30,000-gallon capacity each). In a September 23, 2005 Site Reassessment letter from the Puerto Rico Environmental Quality Board (EQB) to the USEPA included as an appendix in the 2019 HRS Report, it was reported that these ASTs were used to collect non-hazardous wastewaters and were emptied and cleaned before PROTECO ceased their operations. No attempt was made during the SRV to open or inspect the ASTs to determine if any liquids were present. Photo 10 shows a partial view of the AST area.

Photo 10: Partial View of AST Area

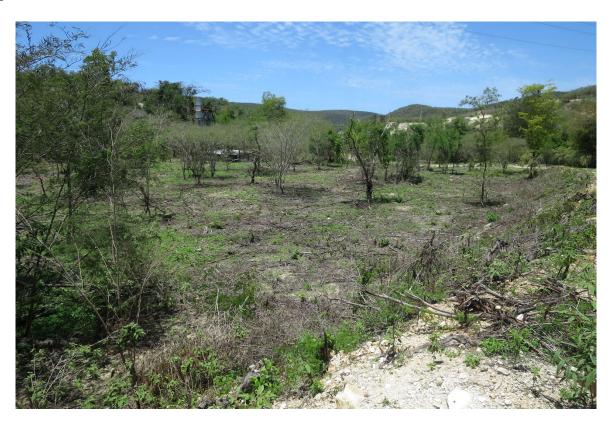
The group walked from the ASTs to the reported (Weston 2019) general location of WU 8. No visual indicators are present to define the location of WU 8. No survey data for WU 8 was contained in the HRS Report (Weston 2019). Since there is no physical/visual indication for the location of WU 8 it was not possible for Geosyntec to place survey stakes for this WU with any reasonable degree of certainty. A small mound of soil with apparent liner material is located to the west of the reported WU 8 location. However, at this time it is not possible to know if this material was associated with WU 8. Photo 11 shows a general view of reported location of WU 8.

Photo 11: General View of Reported Location of WU 8

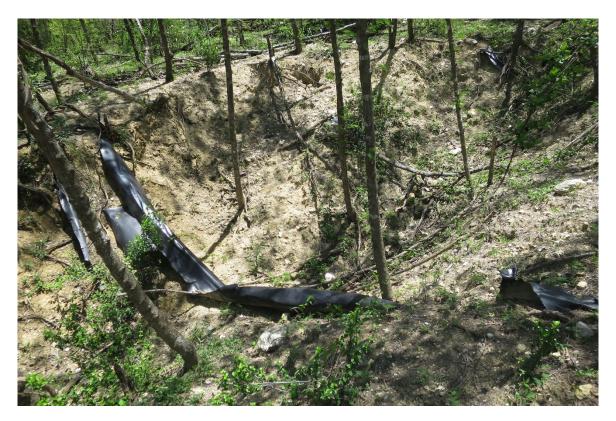
The group walked to WU 13 which is located to the east-southeast of CAMU 9. An erosion area is located on the west flank of WU 13. Liner material appears to be exposed in this erosion area (see photo 13).

Photo 13: View of Erosion Area on Side Slope of WU 13

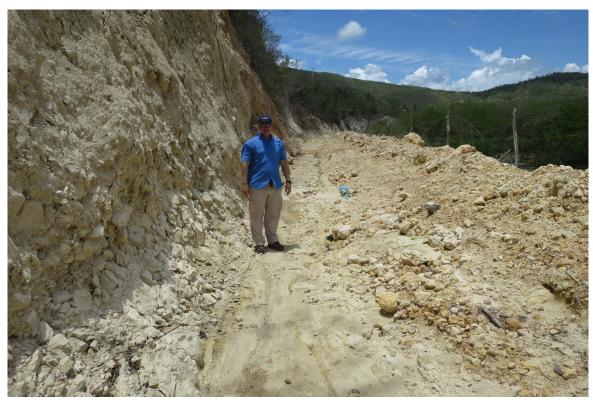
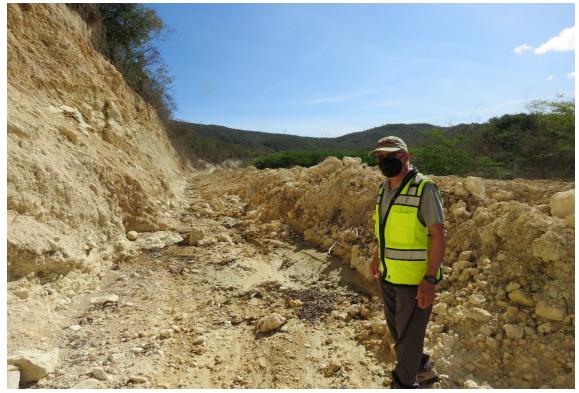
de maximis and Geosyntec walked to the bypass canal and took pictures to document the conditions on May 3, 2022 to compare them to photos taken on June 25, 2021. Photos 17 through 20 compare the condition of the bypass canal and the west abutment of the lower sedimentation dam from June 25, 2021 to May 3, 2022. The photos show that the bypass canal was still present on May 3, 2022 and is still functioning to channel stormwater from EC Waste and the [northern] portion of the Proteco Site so that it does not enter the sedimentation ponds. The photos also show the current condition of the west abutment of the lower (primary) sedimentation pond dam. The bypass canal and west abutment of the sedimentation pond dam appear to be in a worse condition than was previously reported to EPA in June 2021. It would appear that the stormwater which has flowed through the bypass canal since the June 2021 visit has eroded more soil material from the sediment pond dam's west abutment and the adjacent hillside.

Photo 17: Todd Kafka in Bypass Canal, May 3, 2022

Photo 18: Raul Colon in Bypass Canal, June 25, 2021

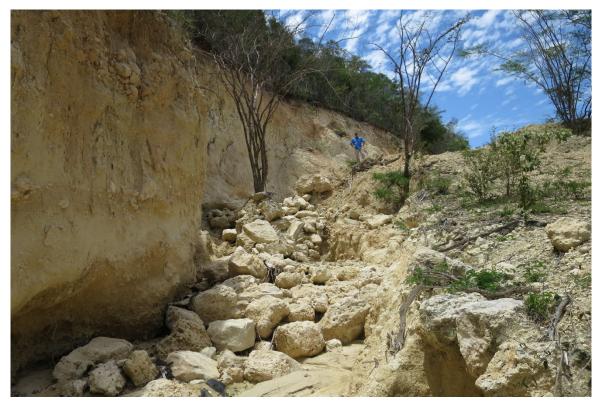
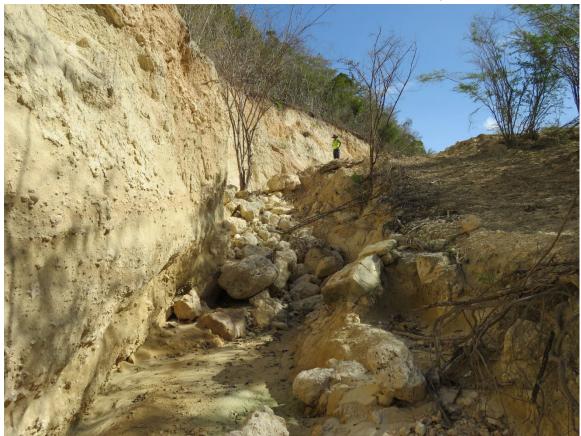
Photo 19: West Abutment Lower Sedimentation Pond, May 3, 2022

Photo 20: West Abutment Lower Sedimentation Pond, June 25, 2021
